The Performance of House Foundations in the Canterbury Earthquakes

Master of Engineering in Civil Engineering

Duncan Henderson

August, 2013

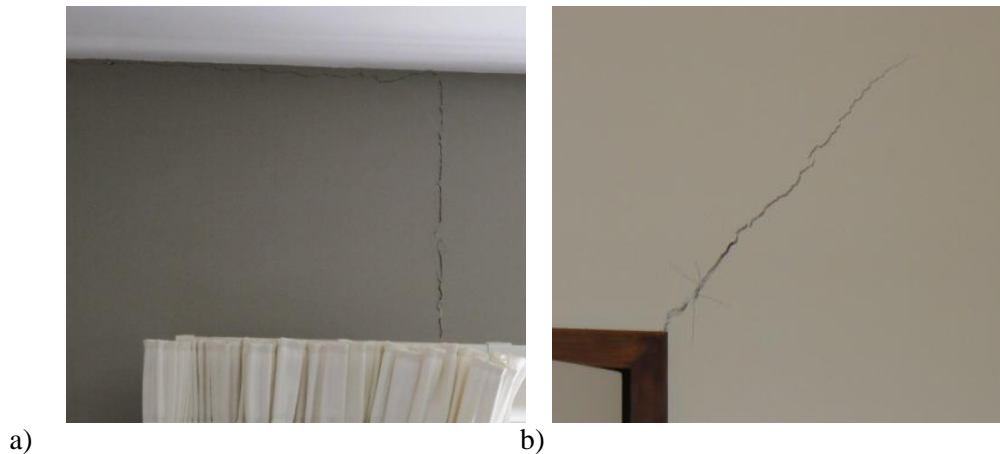
Damage to interior linings involved cracking in the various gypsum and plaster board claddings found in residential houses in New Zealand. Minor cracking as shown in Figure 3.6 often occurred at joints in the plasterboard, or at wall openings such as the corners of door and window frames.

Figure 3.6. Interior lining damage, a) low damage vertical crack in plasterboard above window and b) low-moderate diagonal crack above door in plasterboard.

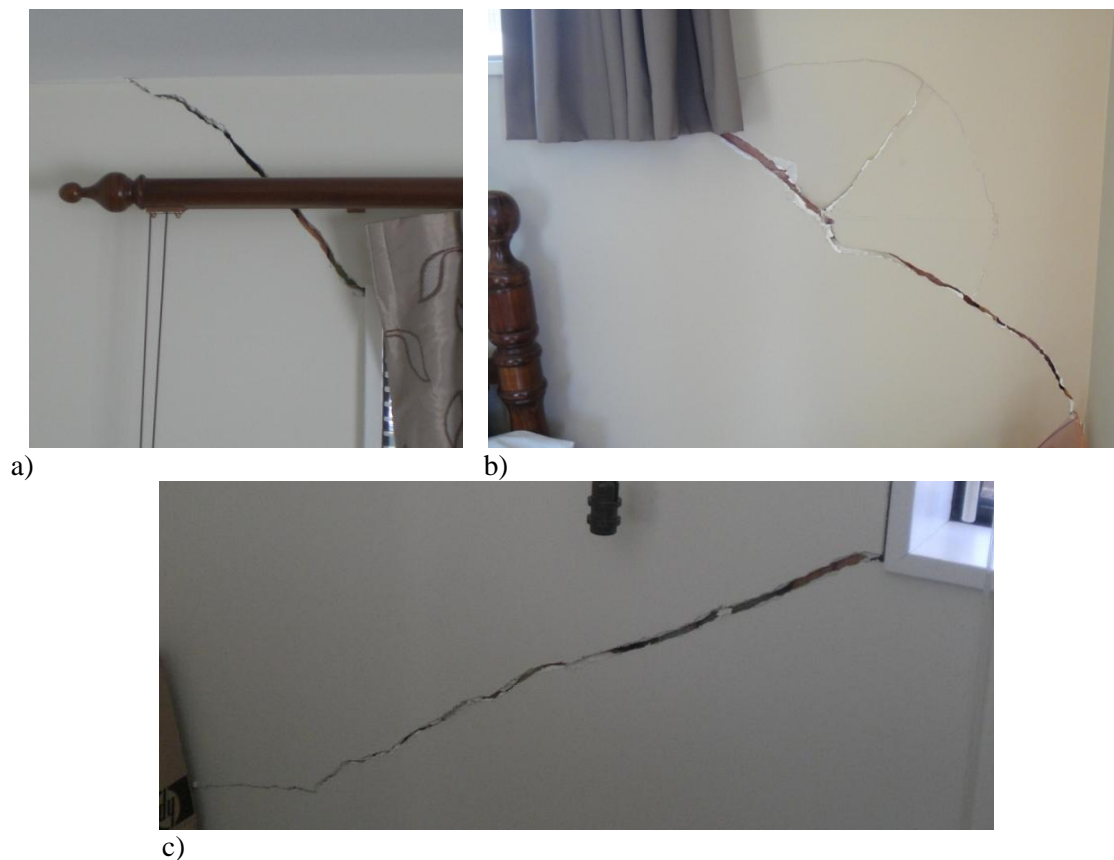
Higher levels of damage to interior claddings involved larger cracking and separation in plasterboard, as shown in Figure 3.7. Again this is more likely to occur at the corners of openings, where concentrations in stress are present.

Figure 3.7. Interior lining damage, a) moderate-high diagonal crack in plasterboard above window, b) and c) high-severe diagonal cracks in plasterboard at window corners.

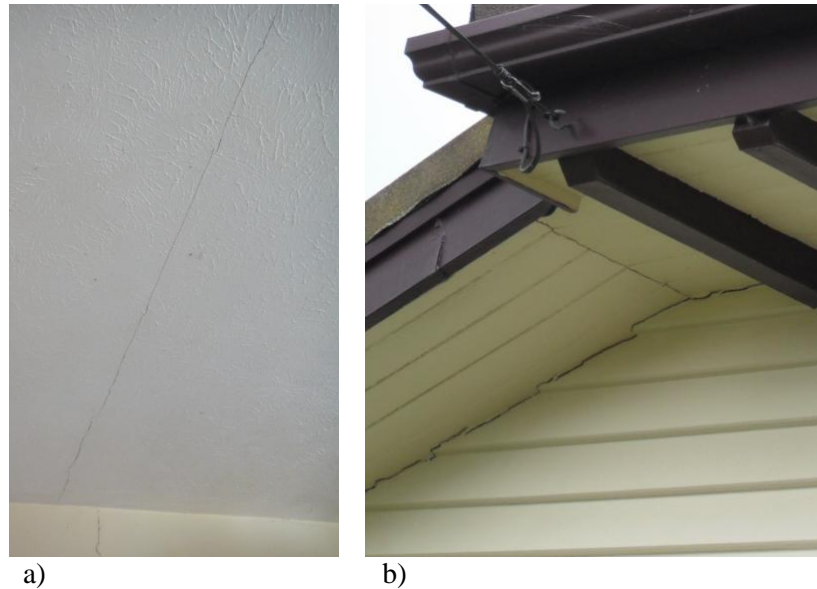
Damage to roofs and ceilings was generally not severe, except in the most extreme cases on lateral spreading. Typical exterior damage was the separation between the wall and roof interface as shown in Figure 3.8.(b). Interior damage was again seen as cracking in the gypsum and plaster board ceilings, again often at joints (Figure 3.8.(a) and Figure 3.9).

Figure 3.8. Ceiling and roof damage, a) low cracking at plasterboard joint in ceiling, b) low-moderate cracking and separation between weatherboard wall and roof.

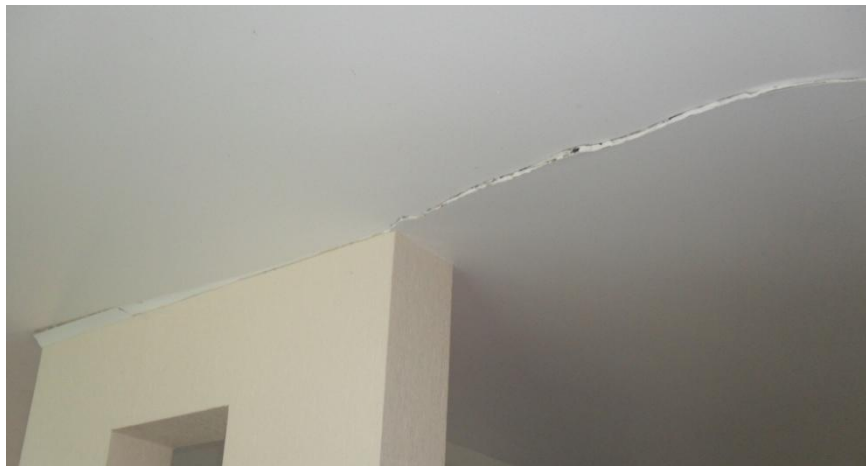
Figure 3.9. Moderate-high damage to ceiling, cracking through plasterboard.

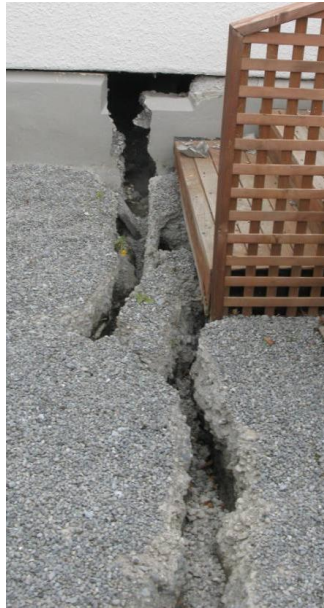
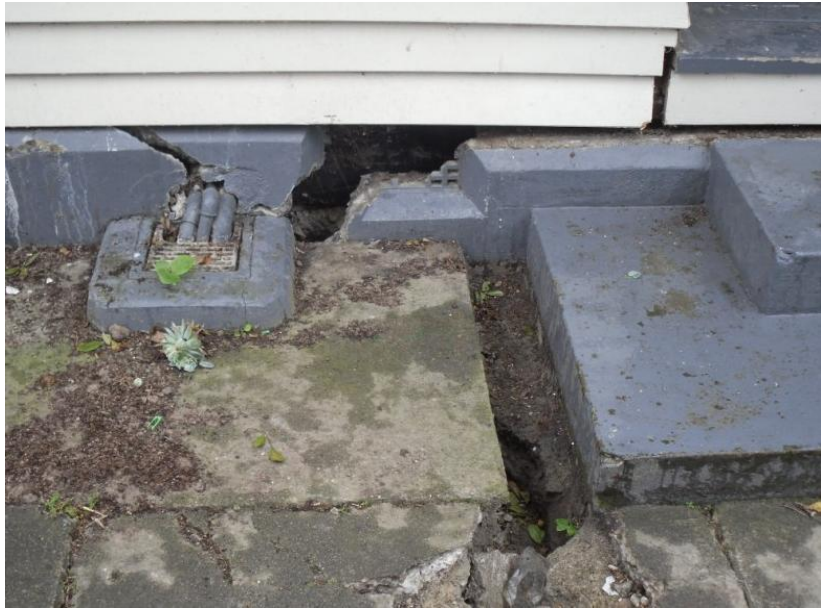
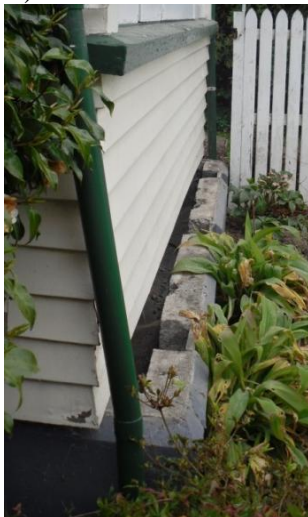
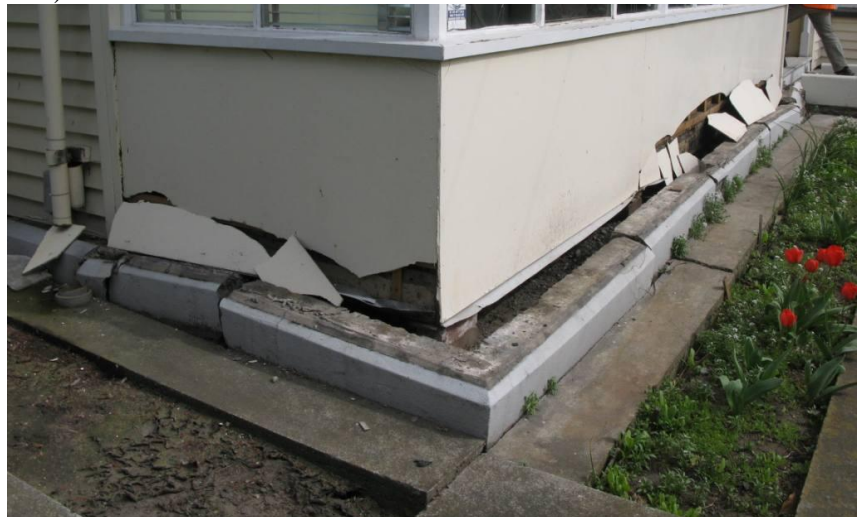
Lateral spreading caused the most severe damage to concrete perimeter foundations. As shown in Figure 3.11.(a) and (b), the perimeter is pulled apart by the ground movement, causing large cracks and extensive separation in the foundations. In extreme cases, lateral spreading can pull or push the concrete perimeter out completely from under the superstructure, as shown in Figure 3.11.(c) and (d). This can result in the superstructure sinking down inside the foundation causing severe structural damage.

Figure 3.11. Lateral spreading damage to concrete perimeter walls, a) and b) spreading cracks in ground causing cracking and large separation of perimeter, c) perimeter pulled out from under house by lateral spreading and d) perimeter pulled out from house on two sides and cracked by lateral spreading.

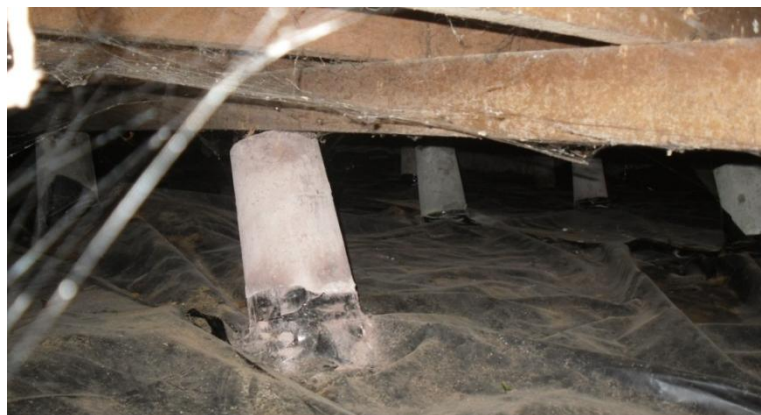
Figure 3.12. All piles under floor failed due to tilting caused by permanent lateral displacement of foundation relative to superstructure.

Failures were also seen in some short piers that support the floor in concrete perimeter foundations. Where significant lateral movement of the foundation or superstructure occurred, piers attached to the sub-floor structure could be pulled over due to their short depth of embedment (Figure 3.12).

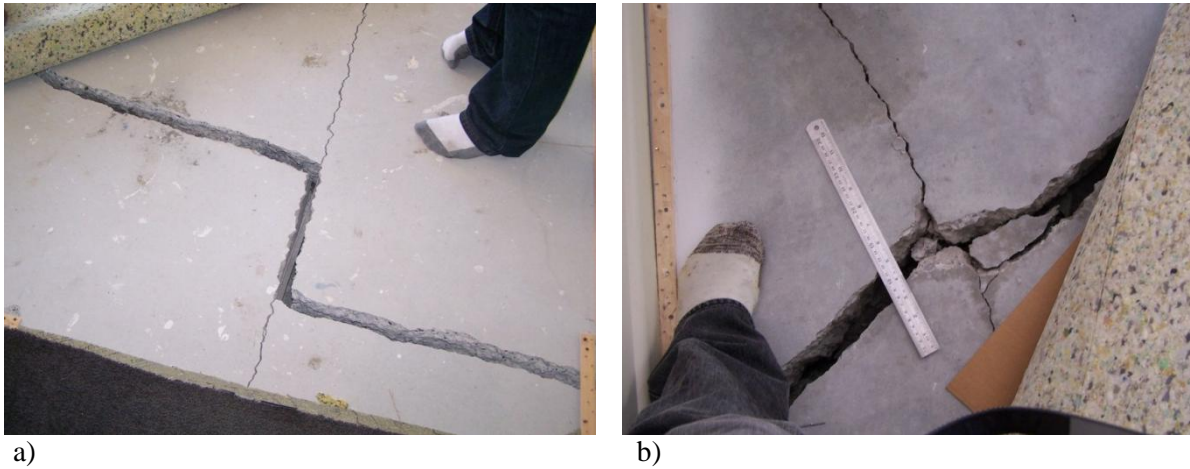
Figure 3.13.(c), (d), (e) and (f) and Figure 3.14.(a) and (b). There were a small number of vertical offsets in cracks, as shown in Figure 3.13.(f) and Figure 3.14.(b). The slab cracking found did not seem to follow any typical patterns as to where or how the cracking occurred.

Figure 3.14. High-severe damage to slabs involving cracking and separation, shown in both a) and b).

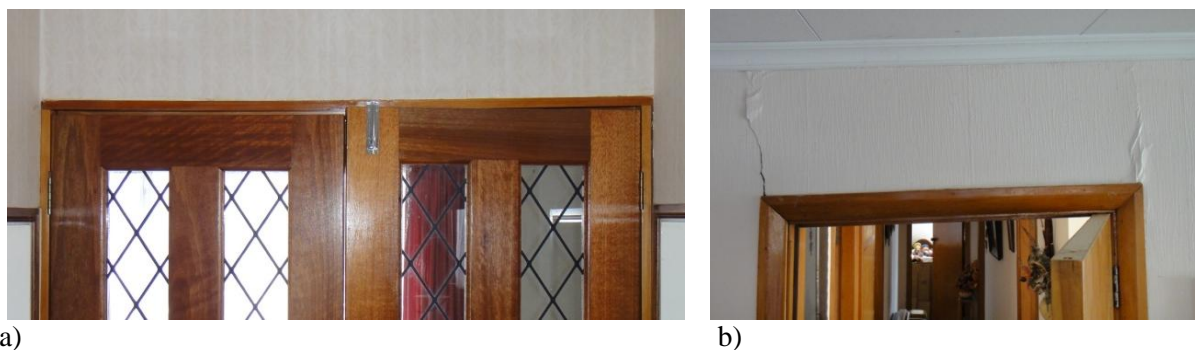
The most common visible structural damage was racking of walls. Other forms of structural damage such as nail slip and damage to the timber framing were generally not visible in the houses inspected. Racking was mostly observed as mis-alignment in door and window frames, and was seen in both interior and exterior walls, as shown in Figure 3.15 and Figure 3.16. Racking of walls in houses with slab foundations was more uniform, as shown in Figure 3.16.(a), due to uniform differential tilting of the slab while the superstructure tries to remain upright. Racking in houses with concrete perimeter foundations tended to be less uniform, as shown in Figure 3.15.(a) and (b) and Figure 3.16.(b), due to the more flexible deformation modes of this type of foundation.

Figure 3.15. Structural damage, a) and b) racking of internal doors due to differential settlement

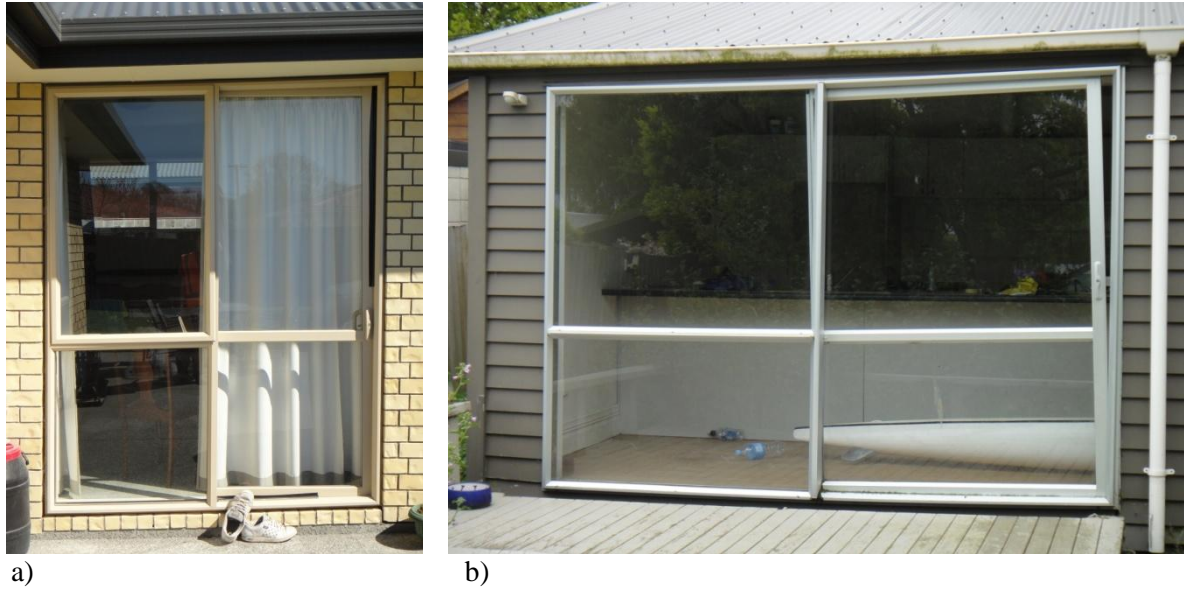
Figure 3.16. Structural damage, racking of external doors due to differential settlement, a) slab-on-grade foundation showing constant racking and b) concrete perimeter showing differential racking.

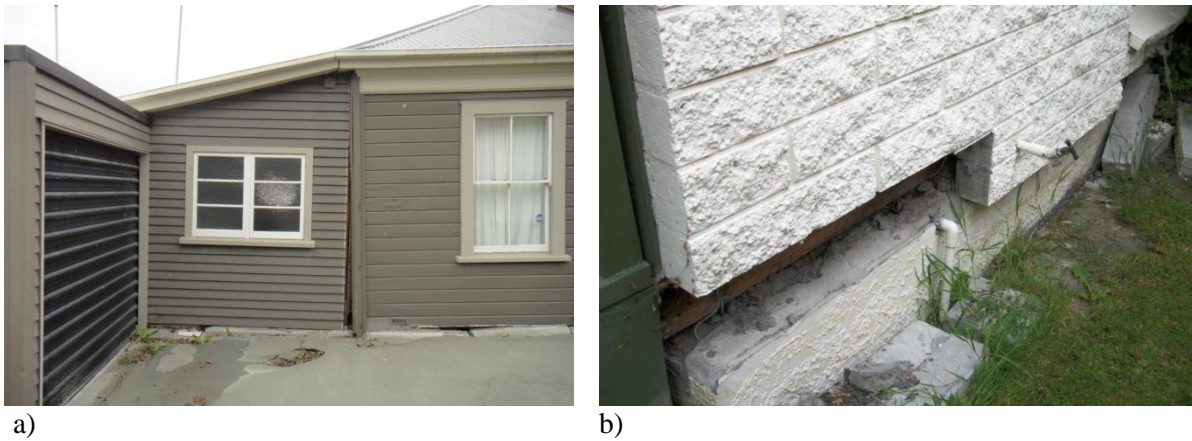
Another common type of structural damage occurred at the interface between external walls and the foundation. This was manifested in a number of ways, such as cracking along the interface, vertical separations and pushing out or misalignment of the wall and foundation, as shown in Figure 3.17.(b).

In a few extreme cases there was total separation of whole sections of the structure as shown in Figure 3.17.(a), where both the superstructure and foundation were ripped apart.

Figure 3.17. Structural damage, a) differential settlement causing separation between sections with different foundations and b) push-out of wall over concrete perimeter foundation wall causing collapse of bricks.

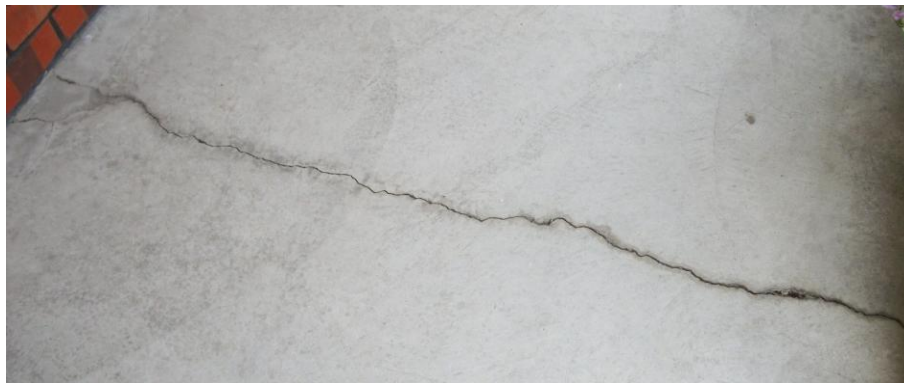
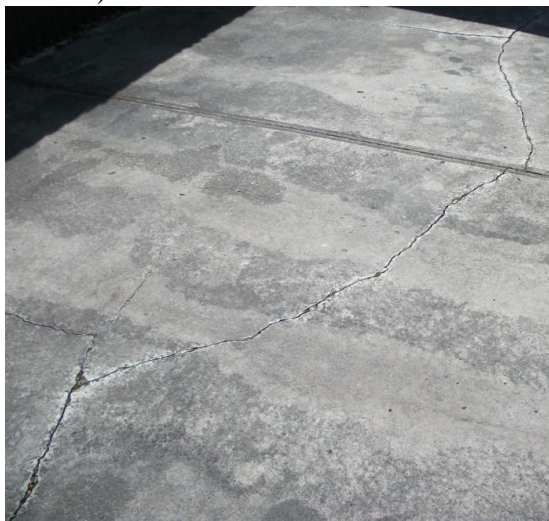
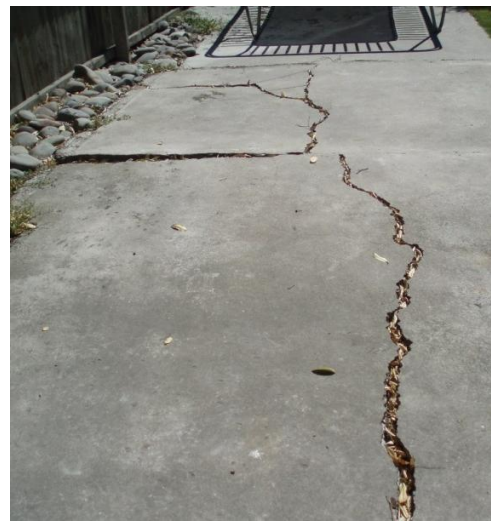
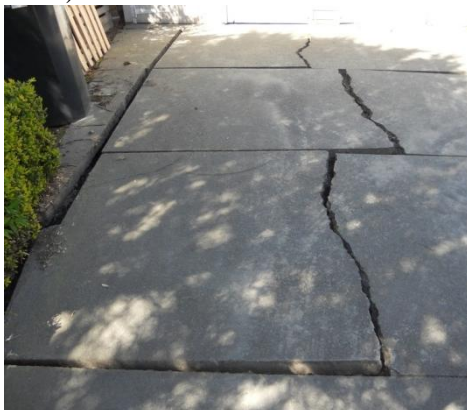
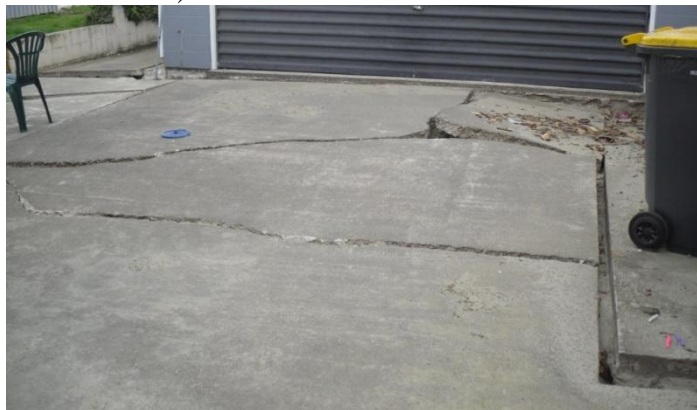
The most common damage to surrounding property was cracking in concrete paving. This was more common than cracking in concrete slab foundations, as paving is weaker and more easily affected by liquefaction, as it is cast straight onto the ground. Minor and moderate damage consisted of small cracks and low levels of separation between slab sections, shown in Figure 3.18.(a) and (b). More severe damage involved larger cracks and significant separation and break-up of paving, along with differential tilting and settlement, as shown in Figure 3.18.(c), (d) and (e).

Figure 3.18. Damage to concrete paving, a) low, b) low-moderate cracking, c) moderate, d) high and e) severe cracking, break-up, differential settlement and separation.

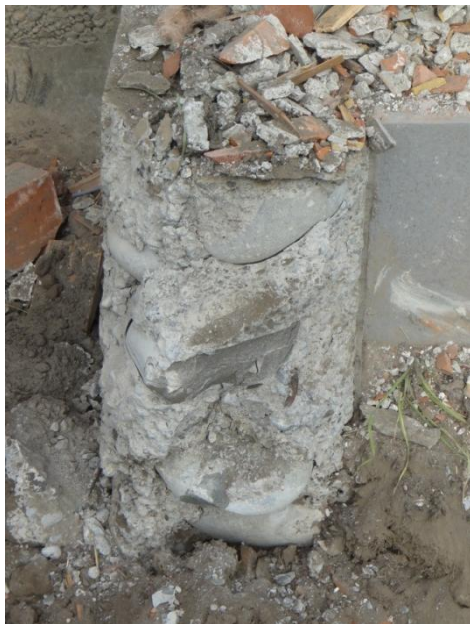
Most older houses constructed before 1980 in Christchurch and New Zealand have concrete perimeter foundations with short piers, shown in Figure 4.3. The primary vertical and lateral load-resisting component of this foundation type is a concrete perimeter wall, which is generally 150-300mm wide, cast into the ground 100-300mm and extending above the ground 200-600mm. This supports most of the weight of the roof, the external walls and tributary areas of the interior walls and can be constructed of bricks or various grades of concrete which can be unreinforced or reinforced in different layouts, depending on the age of construction and corresponding housing standard. The biggest change in construction methods came with the introduction of N.Z.S.S. 95 in 1935. Prior to 1935, there was no standard of construction for house foundations. The concrete perimeters were made of concrete with widely varying properties, were often unreinforced, and used large stones, bricks or other hardfill to reduce the volume of concrete required (see Figure 4.1). With the introduction of standards-based construction, the dimensions, reinforcing content and layout and concrete strength of the perimeter foundation walls all became prescribed. This ensured a better quality of construction. A review of housing standards can be found in Chapter 2, Section 2.5.1, with summary drawings for the foundations of each period of construction in Appendix A.

Figure 4.1. Concrete perimeter wall cross-section, showing large stones used as fill.

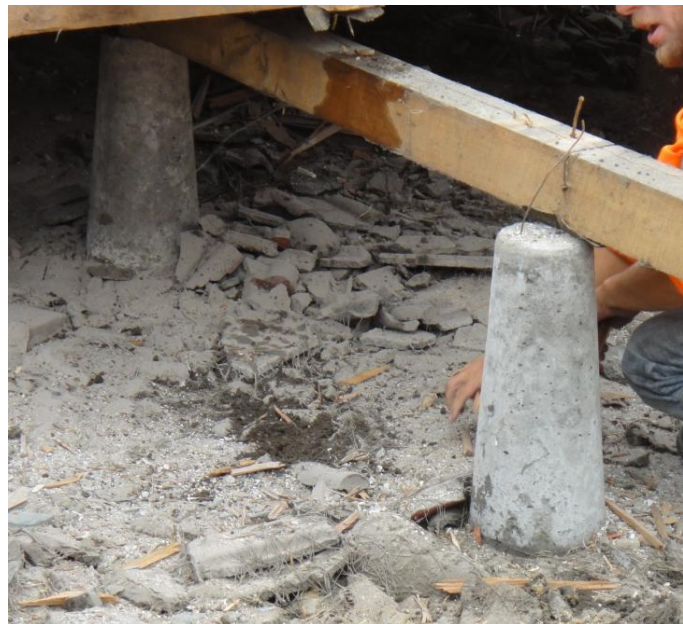
Figure 4.2. Round tapered pier supports, showing connection to bearers.

The secondary vertical load-resisting component of this foundation type are the short pier supports that support the interior floor (Figure 4.2). These are entirely separate from the perimeter wall, and only support the weight of the floor and some internal walls. They can be timber, pre-cast or cast-in-situ concrete with a range of reinforcing. They are generally cast into the ground by 100-300mm, and extend anywhere from 100-600mm above the ground to support the floor bearers. They are connected

to the floor above with wire hooks, which do not provide a rigid connection, but simply hold them in place. It is not uncommon, particularly in older houses, to find that this attachment has been neglected, and the floor is just sitting on top of the piers.

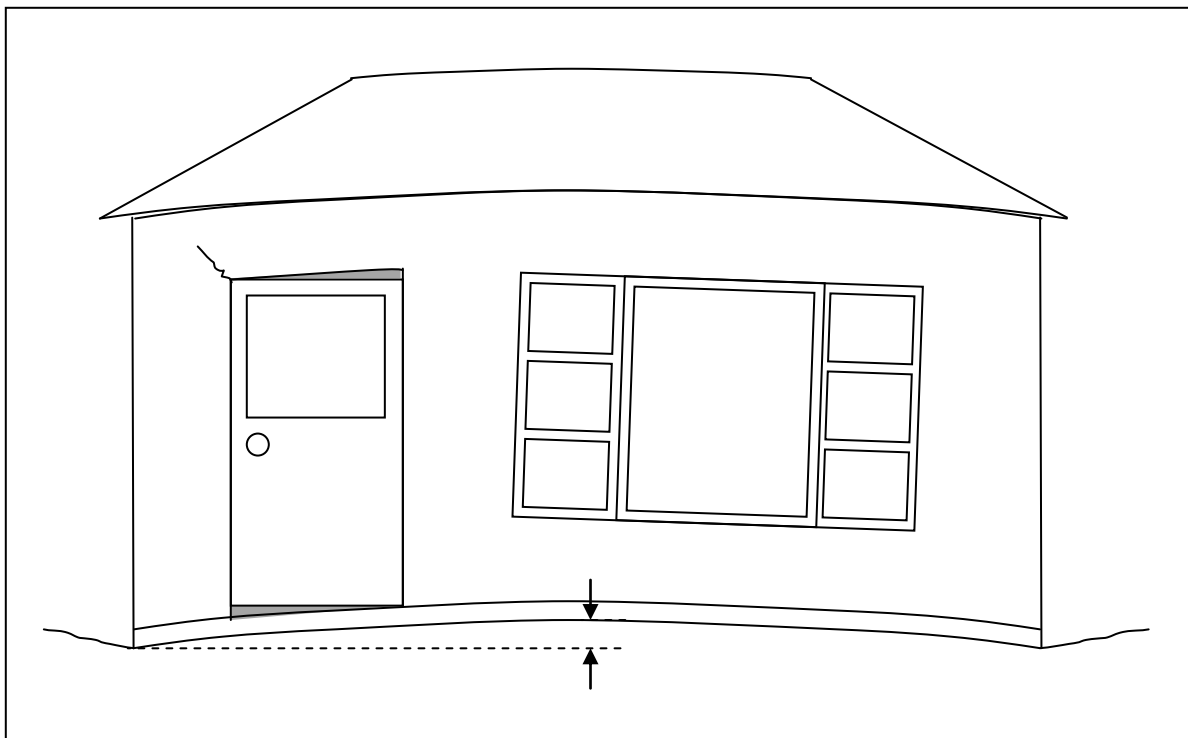
Hogging is typically where the centre of the building has raised up above the perimeter, or the perimeter has sunk down more than the interior, or a combination of both. It can be caused by the upwelling of sand ejecta beneath the inner part of the foundation, pushing it upwards, or by the extra structural weight on the perimeter of the foundation causing it to settle further under loss of bearing pressure. To be classed as hogging, the interior floor must be raised over a significant part of the house (i.e. generally more than one room). If it is less than this, the deformation may be classed as no distinct mode, or complex tilting, depending on the severity. Hogging can take a multi-directional form where just the centre of the foundation is raised, with all sides lower, or it may be planar, raised across the middle, as shown in Figure 4.20, with only two sides down, where cross-sections through the house all show the same profile. Damage to the superstructure is caused by significant racking and differential movement damage in this deformation mode, as shown in Figure 4.20 for the doorway.

Figure 4.20. Hogging of building, showing racking damage to door frame.

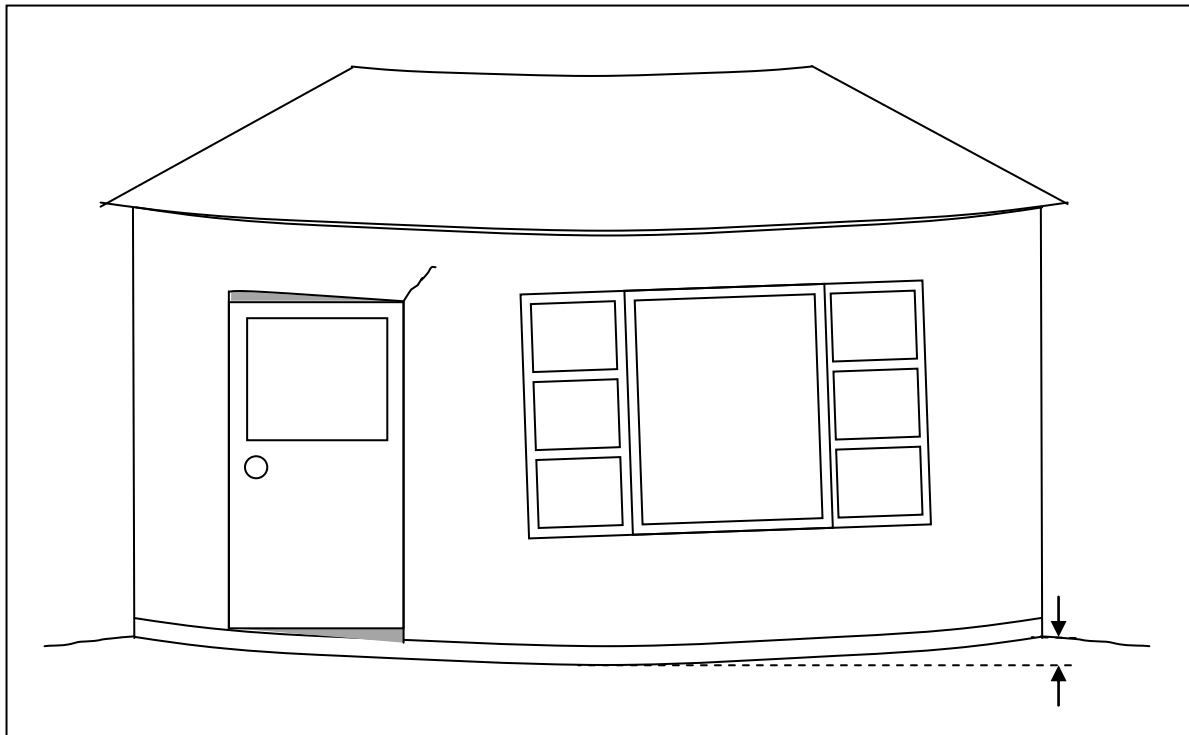
the severity. As for hogging, dishing can be multi-directional with just the centre settled, or planar, as shown in Figure 4.21. Superstructure and foundation damage is again caused by the differential movement of the foundation.

Figure 4.21. Dishing of building, showing racking damage to door frame.

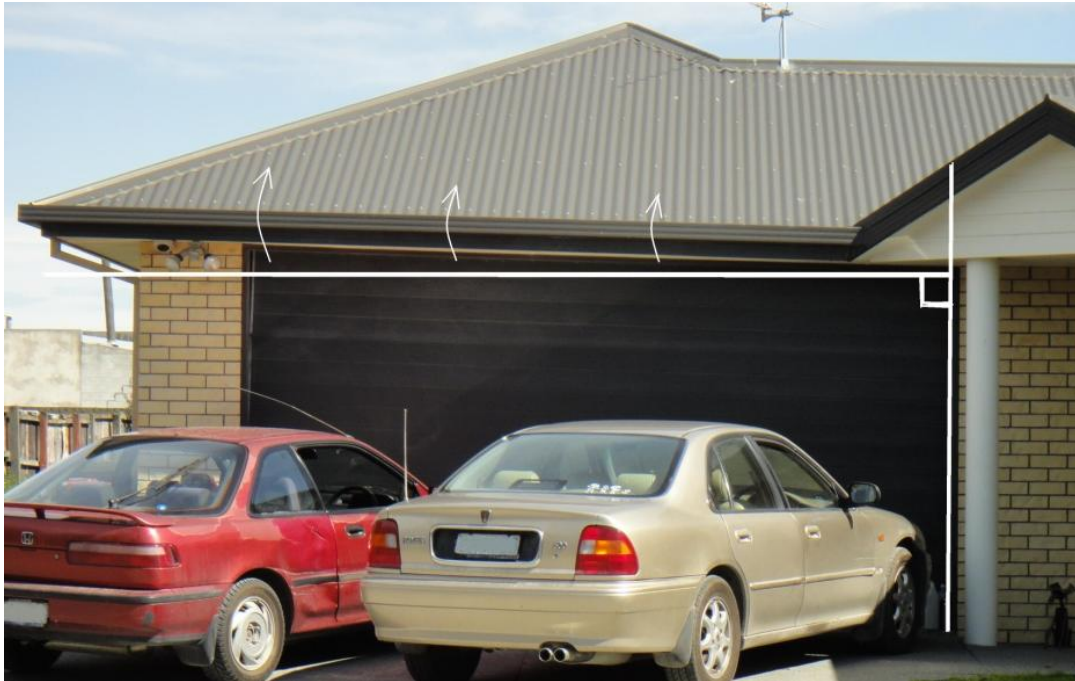
Broken tilting occurs only in slab-based foundations, and more commonly in plain slab-on-grade foundations, due to the weaker slabs. It is where irregular sections of the building plan (i.e. a garage or room that protrude from the main body of the floor plan) break away from the main body, and tilt into, or away from the centre. The settlement can be due to different levels of bearing loss under the footprint of the house, or lateral spreading under an irregular part of the house, causing it to settle and tilt away from the body of the house, or it can be due to loss of bearing under the centre of the house, where this settles more, and the irregular parts tilt in towards the centre. This can be exacerbated if part of the house is 2-storey, as the added weight increases the settlement of the 2-storey section. As the flexural capacity of a basic slab-on-grade foundation built to NZS3604 is quite low, the slab breaks, allowing different levels of settlement in the different parts of the house. Structural damage is often high with this mode (provided the level of deformation is also high), as the differential settlement and break-up of the foundation can cause large cracking and separation in walls and ceilings. Figure 4.23 shows broken tilting of the garage of a standard slab-on-grade foundation house,

Figure 4.23. Broken tilting of the garage of a slab-on-grade foundation house, elevation view.

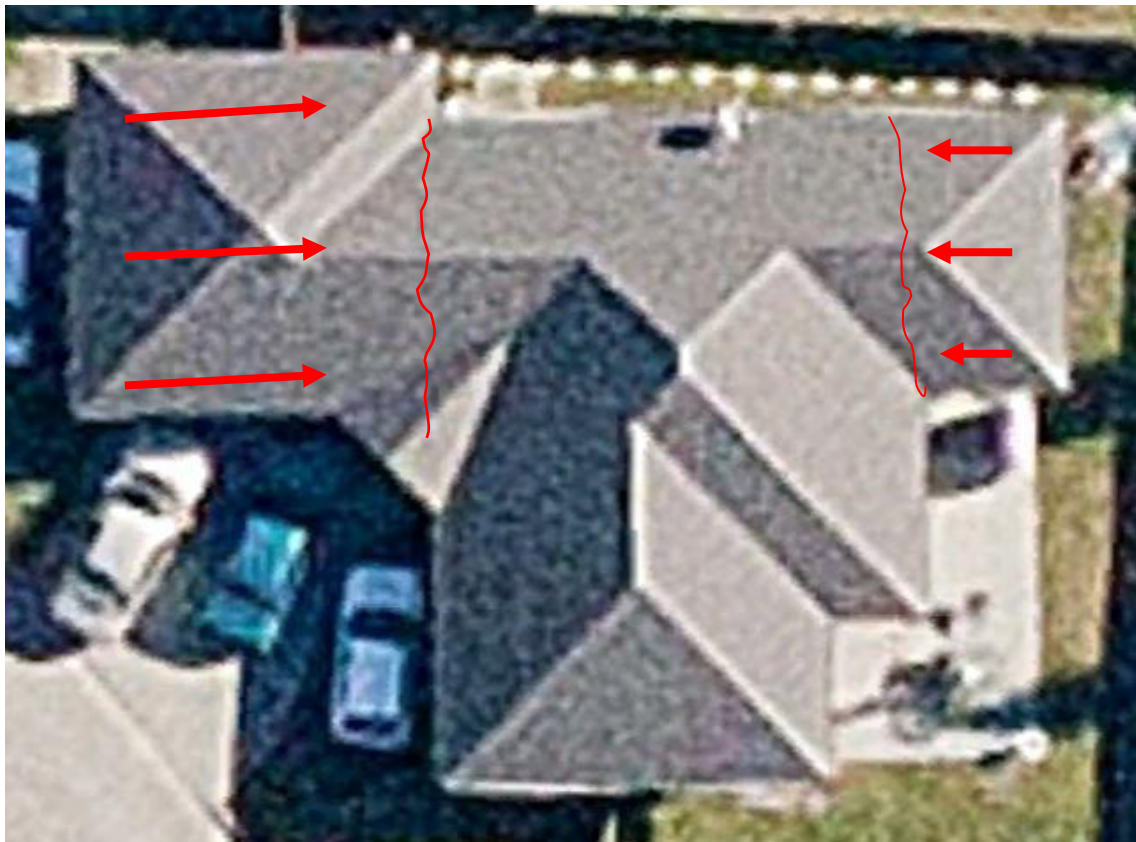
with Figure 4.24 showing how the two protruding wings of the house, the garage and master bedroom, both tilted inwards due to larger settlement of the main body of the house.

Figure 4.24. Broken tilting of garage and master bedroom due to higher settlement of body of house, shown in plan-view.

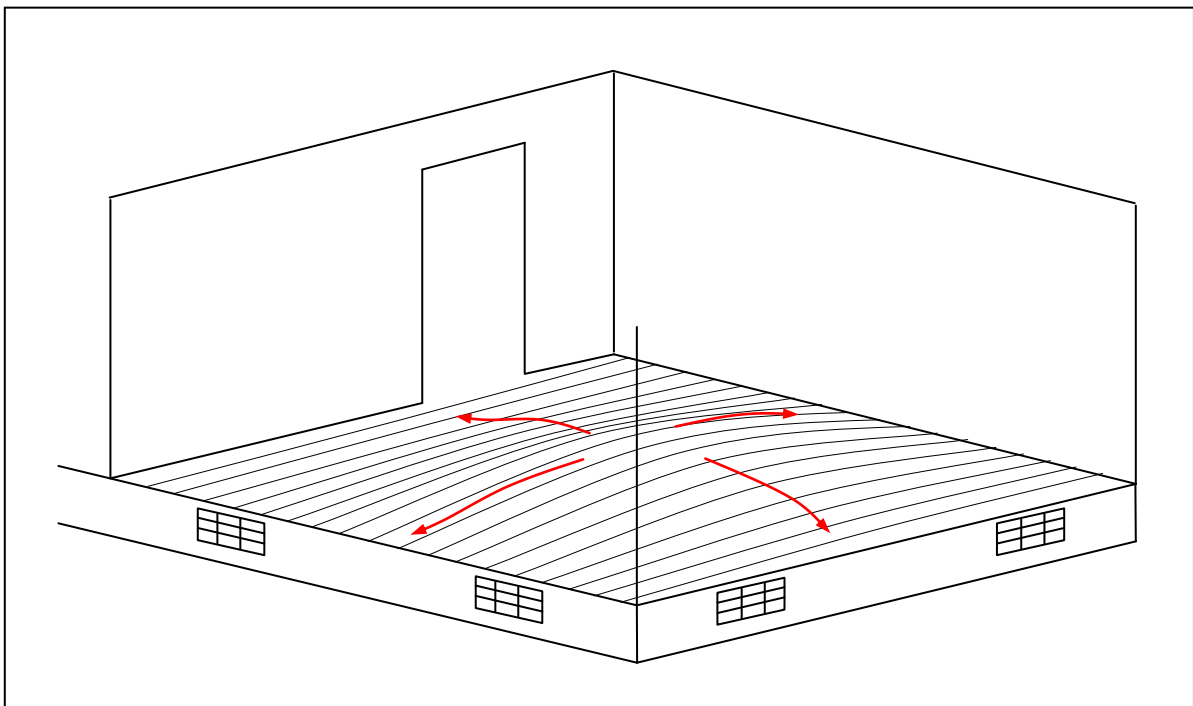
Localised room humping is a mode of deformation unique to concrete perimeter foundations with short interior piers. Differential settlement between the concrete perimeter and the interior piles causes humping of the floor in the middle of rooms in the house, shown in Figure 4.25. It can be caused by two situations. The exterior perimeter supports the exterior walls and the roof load transferred to the external walls. These are often the heaviest part of the house superstructure, and cause larger loads on the concrete perimeter than the interior piles, which only support floor and live loads, and some interior walls. This causes the perimeter to settle further than the interior piles, and the majority of the superstructure settles with it, as it is effectively only supported by the perimeter. This leaves the piles supporting the floors with less settlement, producing the floor humping. This often also results in racking of the superstructure locally, causing doors and windows to jam. The other cause can be when large amounts of sand ejecta push the piles and floor up from underneath the house. This mostly occurs in conjunction with the settlement of the perimeter. Superstructure damage caused by this deformation mode will generally be less than for hogging, dishing or overall humping, as the deformation is confined to one room, and mostly just affects the floor, limiting the damage done to the structure above it.

Figure 4.25. Room humping in a perimeter foundation house.

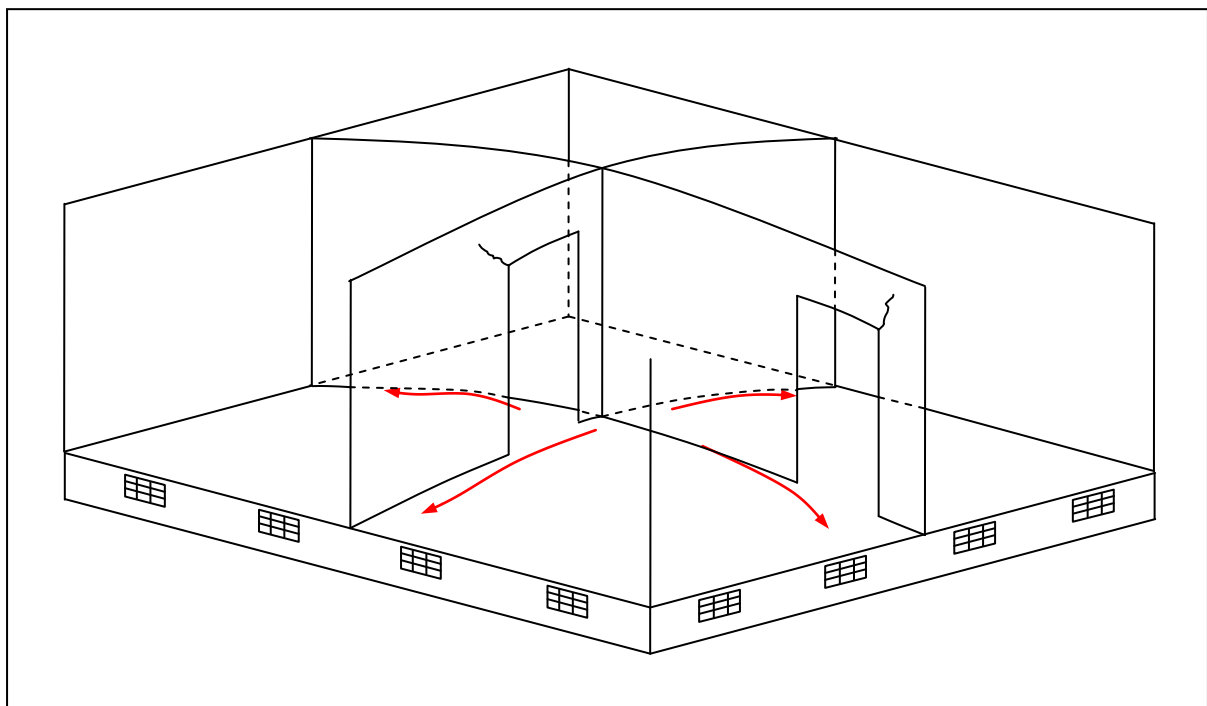
Overall humping occurs only in concrete perimeter foundations with short interior piles. It is similar to localised room humping, the difference being that the humping and settlement of the perimeter is not localised room-by-room, but occurs over the whole house footprint. Some of the piles may settle with the perimeter, while some of the perimeter may not sink as much. The same effects as for room humping are generally still seen, with humping of floors creating large tilt angles and racking of the superstructure causing jamming of doors and windows. Interior brick fireplaces, which are founded on concrete pads, are another location with high foundation loads, meaning these often settle more than the surrounding floors, causing humping around them. Superstructure is generally higher than for the equivalent level of room humping, as the superstructure is directly affected by interior walls also being pushed up with the floor, causing racking and differential displacement, as shown in Figure 4.26.

Figure 4.26. Overall humping of a concrete perimeter foundation house.

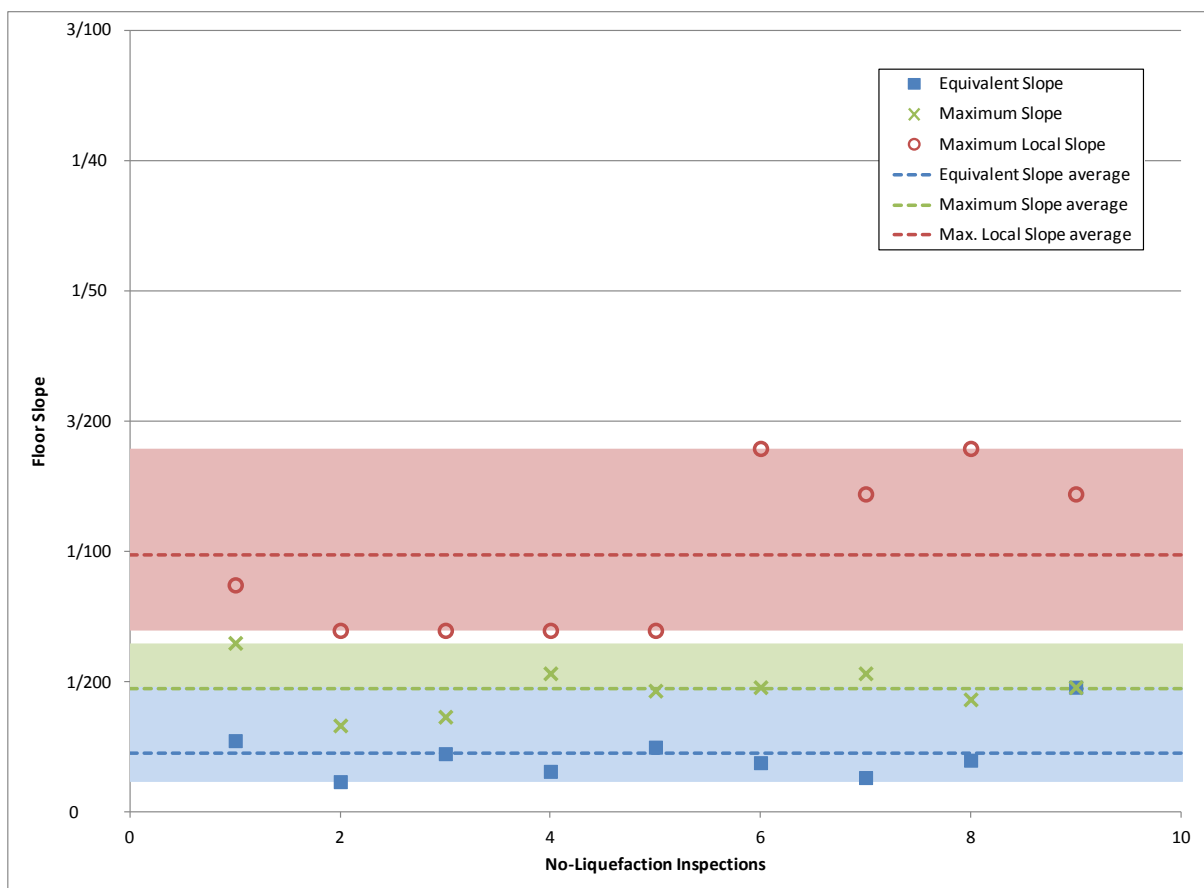
Figure 4.29 and Figure 4.30 show the three different floor slope indices for the inspections of houses that did not suffer any liquefaction effects in Christchurch (shown in Figure 4.13), for concrete perimeter and slab-on-grade respectively. For both foundation types, as the floor slope measurement becomes more localised, the values become larger and more varied. The equivalent slope and maximum slope values show a narrow range when compared to the maximum local slope range. This was also seen in the main body of inspections, and will be discussed later, but it is noted here that the trend appears irrespective of the presence of liquefaction.

Figure 4.29. Concrete Perimeter foundation no-liquefaction inspections

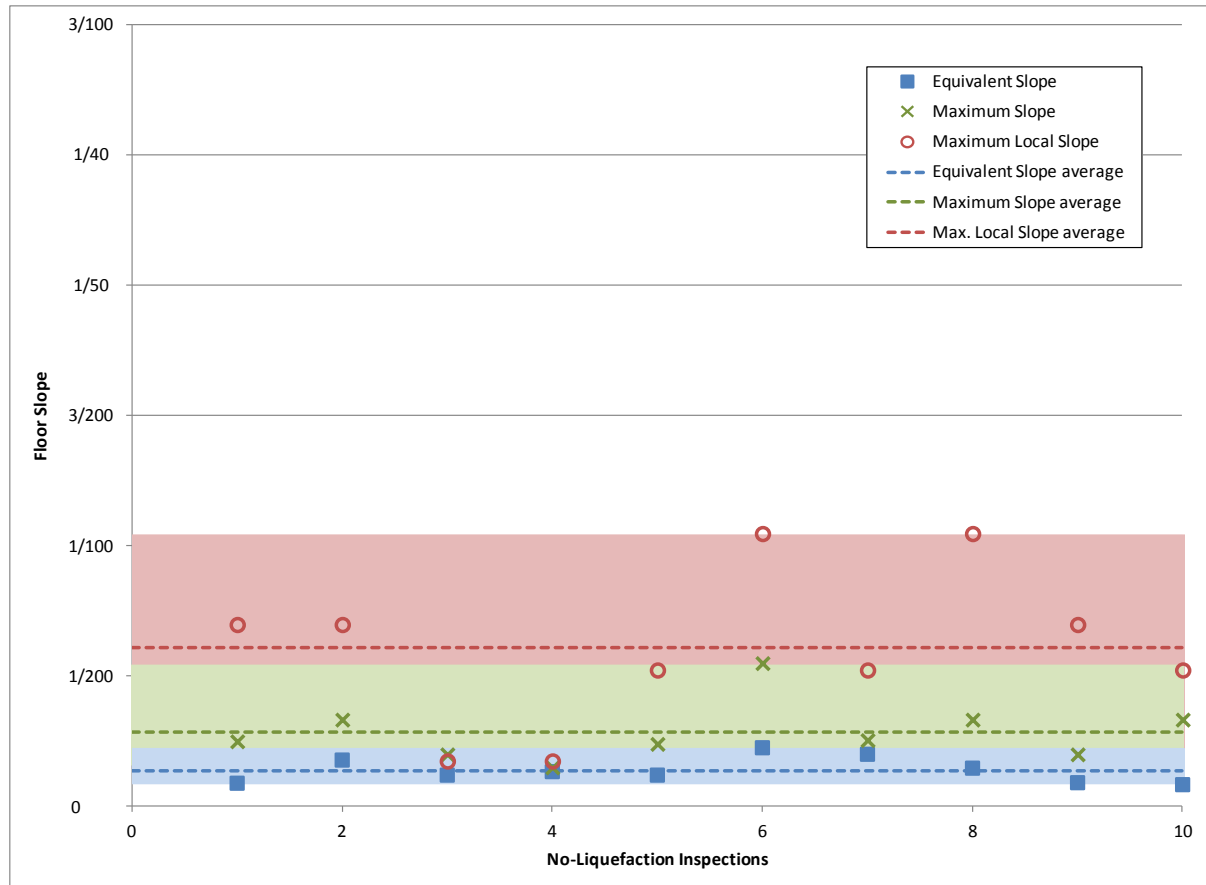
Figure 4.30. Slab-on-grade foundation no-liquefaction inspections.

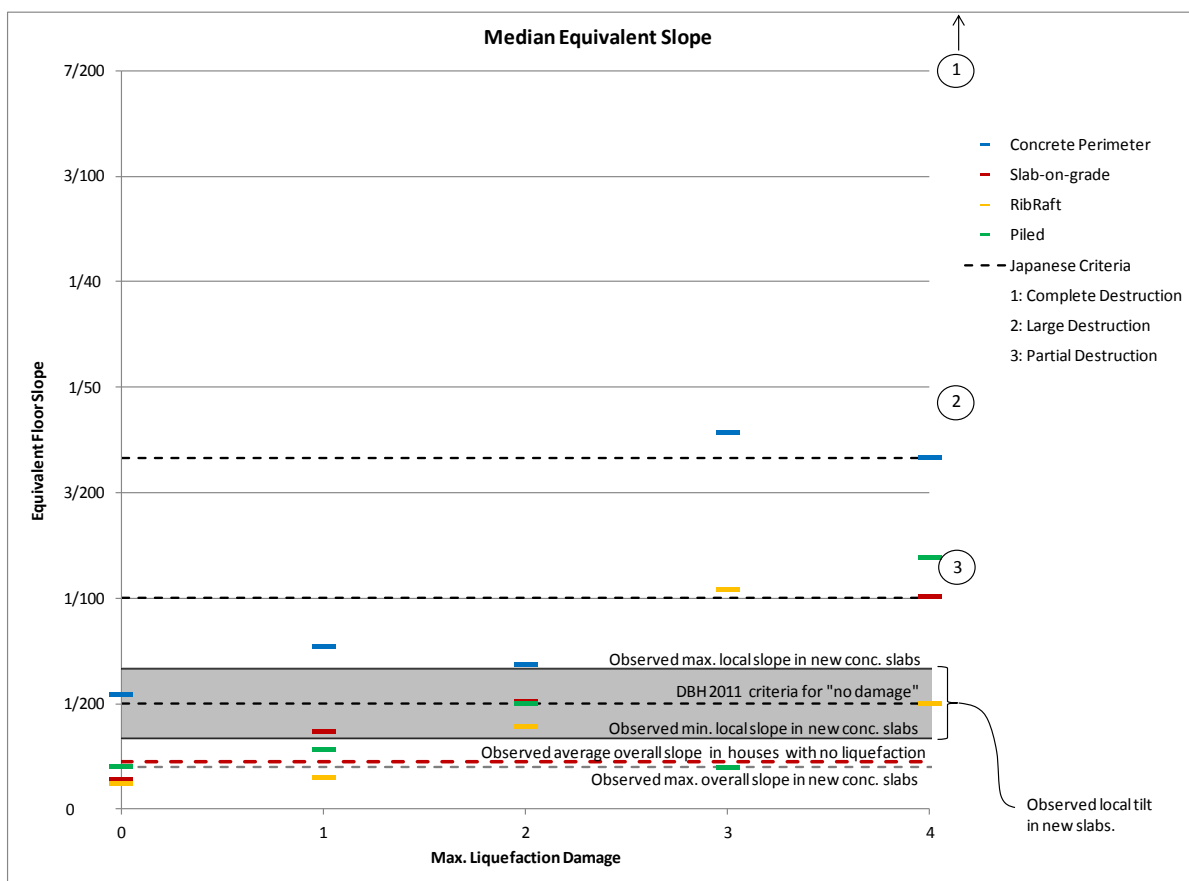
For each of the four different foundation types, there is a clear trend that for an increased level of ground damage, foundation damage also increases. This supports the trend found in Chapter 3 with the 4th September 2010 earthquake data. This trend can be seen in Figure 4.31, which shows the median values for equivalent floor slope for each foundation type at each of the five possible levels of liquefaction severity recorded during inspections. It is also supported by Figure 4.32, which shows the median values for maximum floor slope for all foundation types. Both of these plots show that, in general, as the level of liquefaction increases, so does the floor slope in all foundation types, both over the whole floor, represented by the equivalent slope, and the maximum floor slopes.

Figure 4.31. Median Equivalent Slope values at each level of liquefaction for each foundation type.

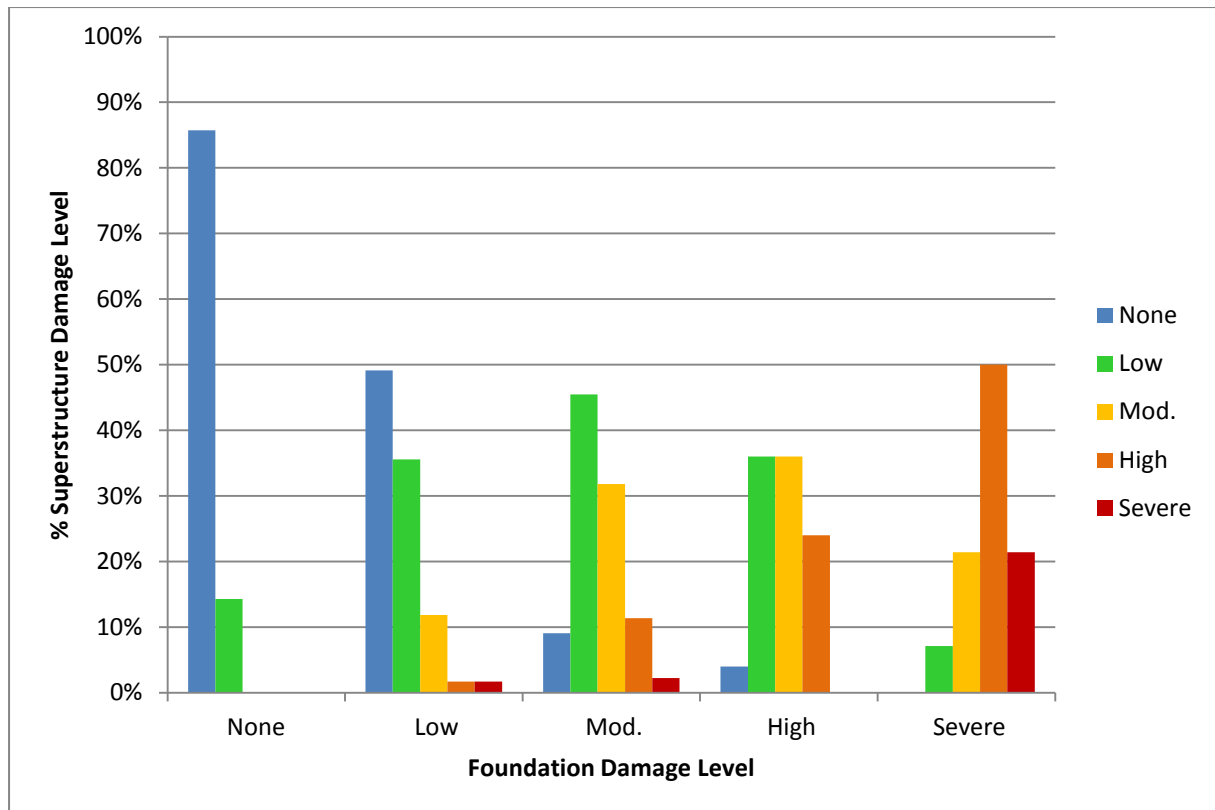
Figure 4.33 shows the distributions of superstructure damage for each level of foundation damage. It illustrates that for all buildings, as the foundation becomes more damaged, more houses suffer high levels of superstructure damage, and less houses have low superstructure damage. This agrees with the post-September data in Chapter 3. The proportion of houses in Figure 4.33 with no superstructure damage drops from 86% when houses also have no foundation damage, to less than 10% for houses with moderate or worse foundation damage, with all houses that had severely damaged foundations experiencing superstructure damage. The percentage of houses suffering high or severe superstructure damage in Figure 4.33 also increases as the foundation damage worsens. For houses with no foundation damage, only 14% had low superstructure damage, and none suffered worse than low damage. This supports the hypothesis from Chapter 3 that superstructure damage beyond the minor level is directly linked to foundation damage when there is liquefaction present.

Figure 4.33. Distribution in percentage of superstructure damage level for differing levels of overall foundation damage.
